Radnor Township Walk Audit Findings

Prepared by: Delaware County Regional Planning Commission

In Fall 2025, the Delaware County Regional Planning Commission (DCRPC) and Delaware Public Health District (DPHD) organized a Walk Audit for Radnor Township. Attendees included DCRPC, DPHD, Delaware County Board of Developmental Disabilities (DCBDD), and Township residents and representatives.

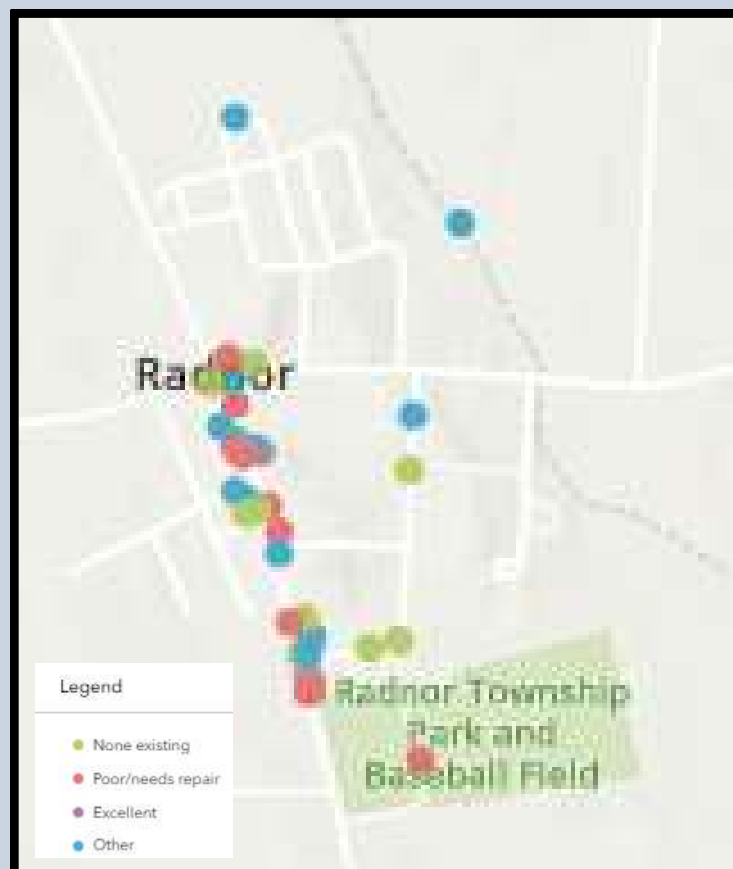
Electronic survey - Geolocated points of interest

Of the **41 responses** (with multiple topics), **23** reported the sidewalks are either too narrow (4' wide) and/or have different types of sidewalk disruption (overgrown with weeds/shrubs, sidewalk ends, in need of repair), **6** reported vehicles parked in the right-of-way (mostly in gravel parking areas), and **7** reported positive feedback (existing street trees on OH-203 and Baker St., raised tactile indicators in good condition, potential for sidewalk/path extensions, and Watch for Children signage).

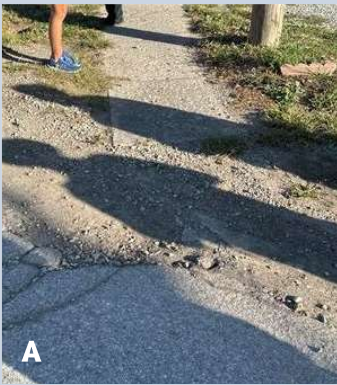
- The sidewalk along OH-203 that connects to the park property is in disrepair. (A)
- Storm drains may be a hazard to pedestrians. (B)
- Sidewalks are only 4 feet wide, which is too narrow. Sidewalks are broken down and grass is growing up between them. (C)

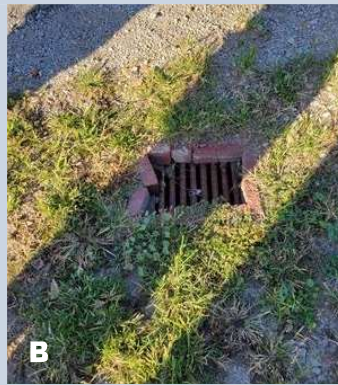
- Sidewalks end in multiple locations, with sidewalks also turning into gravel.
- What appears to be serving as an alley (not platted) and connecting OH-203 and Baker St. is in disrepair. (D)

- Shrubs are overgrown and blocking the sidewalk.
- Post office parking is right off of the roadway and there may be site distance issues for those entering/exiting the parking areas. (E)

- The sidewalk abruptly ends and is elevated just north of the Post Office. (F)
- The ADA ramp in front of D&W Home Solutions is steep and may not be ADA compliant.

- Gravel Parking abuts the sidewalk and does not provide a buffer between the sidewalk and the street. (G)
- Motorcycle parked on, and blocking the sidewalk.

- No east/west crosswalk at OH-203 and Radnor Rd.
- Broken drain cover needs repaired.

- Sidewalk widths are too narrow. They do not accommodate for groups to walking together and should be widened to 5 feet (minimum). (A)
- Sidewalk buffers (tree plantings, berms, etc.) should be installed along OH-203. (B)
- Sidewalks could connect to Radnor Cemetery and even Grace Community Fellowship. (C)
- Shrub trimming is needed along OH-203 to allow the full width of the sidewalk to be used. (D)
- Sidewalk repair is necessary as they are overgrown with grass and covered with debris. (E)
- Crosswalk markings need installed or repainted and ensure all crosswalks are level with the street. (F)
- Consider adding dedicated pedestrian spaces (sidewalk or striping) on some of the side streets and street lighting.
- Gravel parking areas in the ROW may need removed if not permitted. (G)

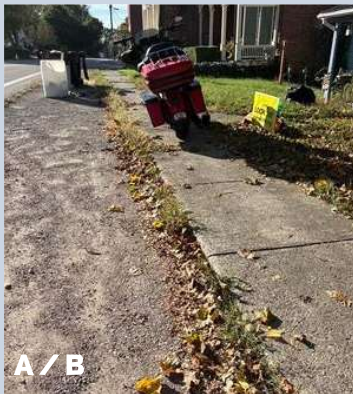
- Sidewalks are only 4 feet wide, which is too narrow. (A)
- Sidewalks are cracked, with grass growing up between them.
- What's the gravel area between the road and the sidewalk used for? (B)

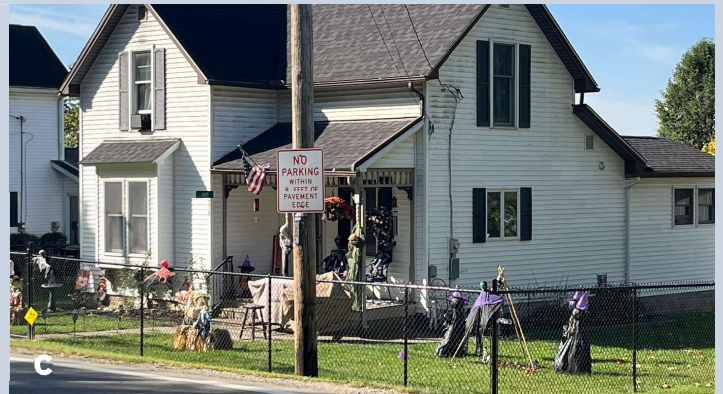
- There are "No parking within 8 feet of pavement edge" signs, but gravel parking is on this property. (C)
- The raised tactile indicators are in good condition. (D)

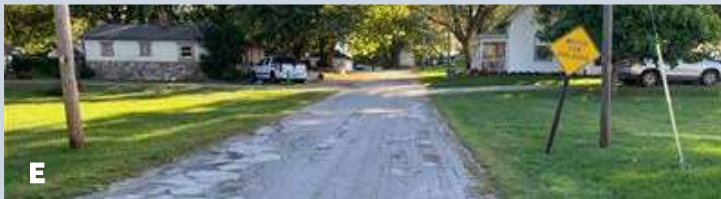
- Sidewalk ends at John St. along OH-203.
- Is parking in the right-of-way (gravel surface) permitted?
- There are no sidewalks on John St./Baker St., but there are Watch for Children signs. Did the community request those? (E)

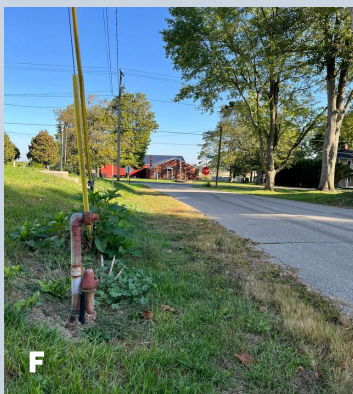
- Excessive noise from barking dogs on Baker St. and it can be heard through a significant portion of town.
- Baker street is narrow and has utilities on the west side of the street that may restrict the installation of sidewalks. The street also slopes to the west and gravel parking areas are in front of some homes. (F)

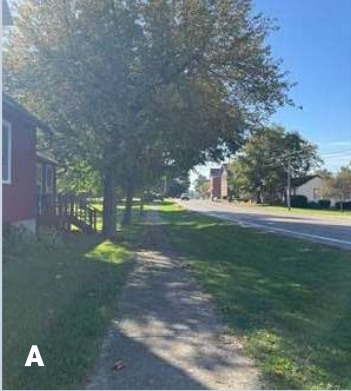
- Existing street trees on east side look good, but are on private property. Continue planting street trees along OH-203? (A)
- Crosswalk striping at OH-203 and Radnor Road needs repainted.
- Shrubs are overgrown and blocking the sidewalk on OH-203.
- There are multiple locations where sidewalks become broken and turn to gravel surface. (B)
- There's no pedestrian infrastructure on the park property. (C)
